Flagler County – Emergency Dune Status

Washington Oaks SP north (Matanzas Shores to county line)

March 9, 2017

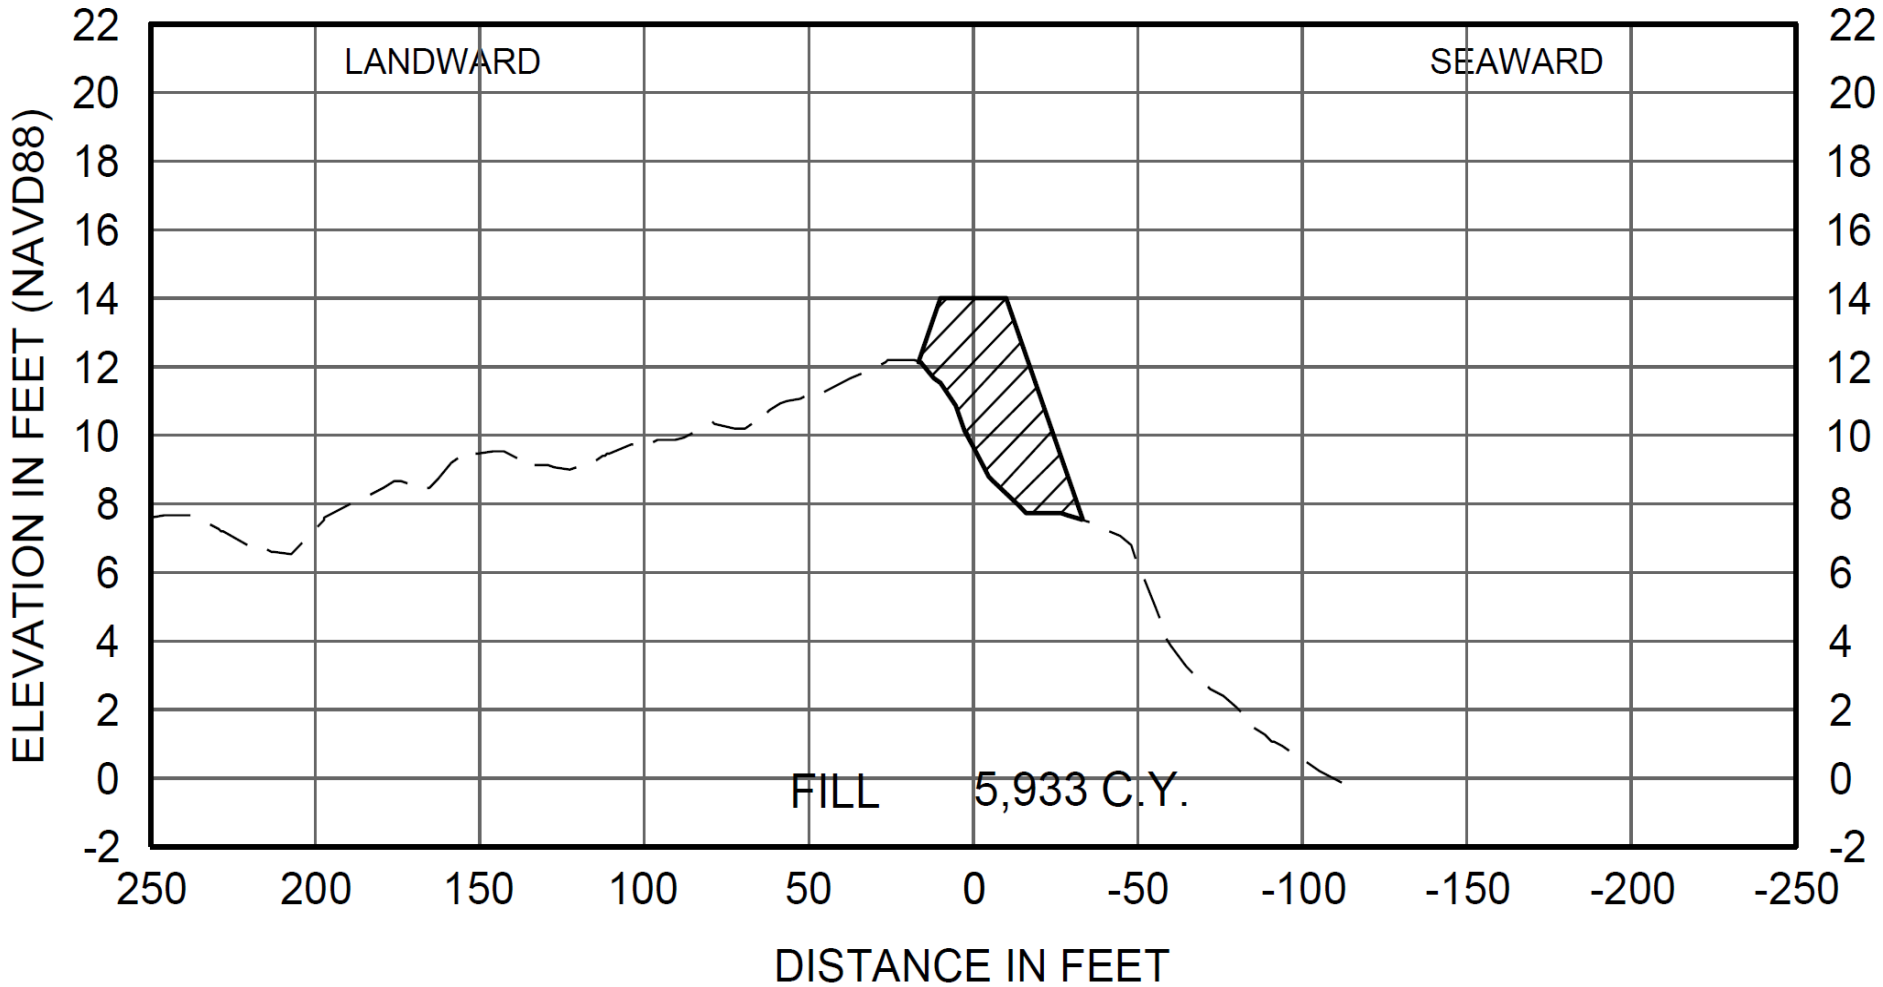
R-MONUMENT #7

Proposed Fill Section
